# Final Report

## Water Line Leak Detection Project for: City of Cannon Beach, OR

Project Dates:  
04/23/2018 through 05/03/2018

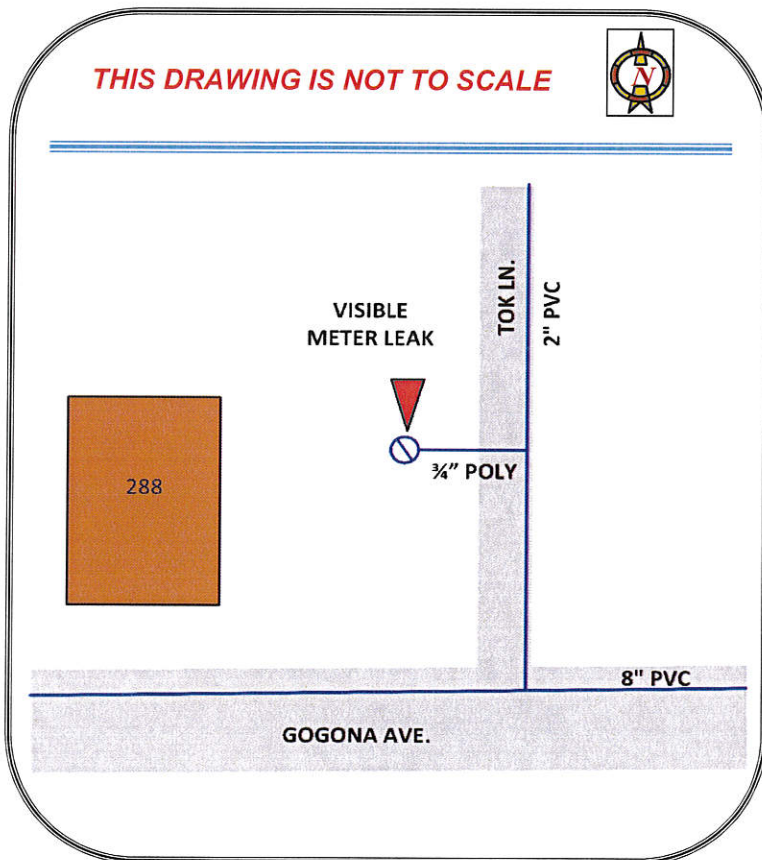
Leak #:	2
Date:	April 24, 2028
Map #:	
Coordinates

REMARKS
STRONG LEAK NOISE AT THE CURB STOP WITH SURFACE WATER IN THE METER BOX. VISIBLE LEAK AT THE METER COUPLING.

EQUIPMENT USED	
	S-30
LEAK INFORMATION	
Leak Consultant:	JT
Leak Class:	III
Leak Rate (GPM):	1.00
Cover Type:	GRAVEL
Site Marked:	YES
Mins. Pinpointing:	15

Recommendation(s): EXCAVATE & REPAIR

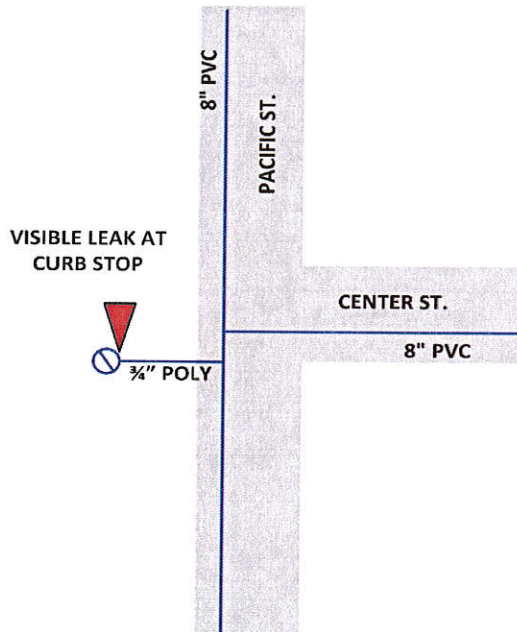
Leak #:	3
Date:	April 24, 2018
Map #:	
Coordinates

LEAK NOISE AND VISIBLE LEAK AT THE CURB STOP.

Leak Consultant:	JT
Leak Class:	III
Leak Rate (GPM):	0.50
Cover Type:	ASPHALT
Site Marked:	YES
Mins. Pinpointing:	15

Recommendation(s): EXCAVATE & REPAIR

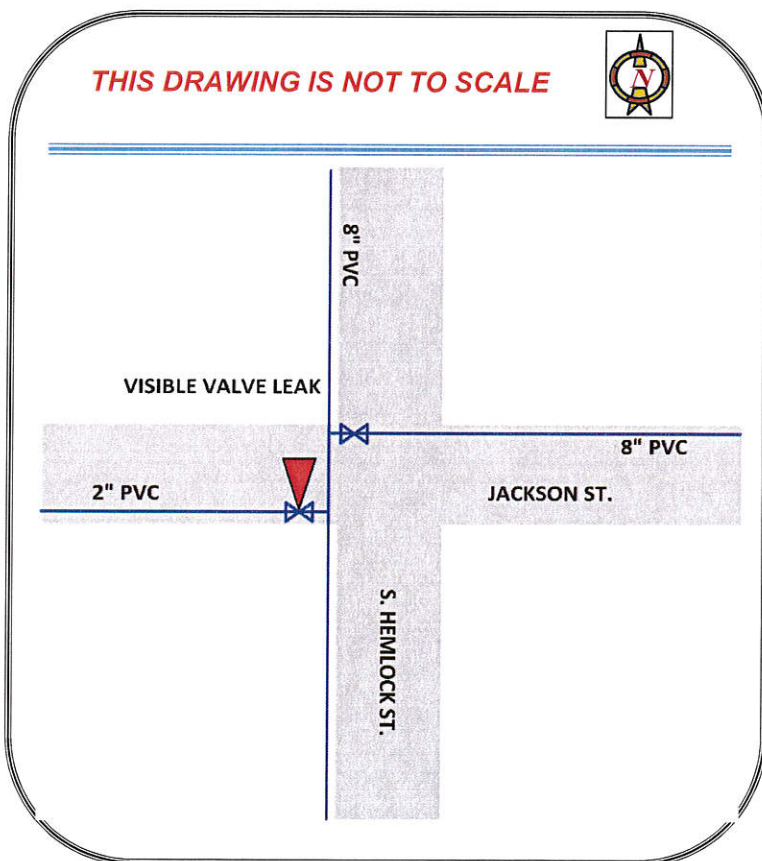
Leak #:	4
Date:	April 25, 2018
Map #:	
Coordinates

REMARKS
NOISE DETECTED ON VALVE. VISIBLE LEAK FROM VALVE, POSSIBLE PACKING LEAK.

EQUIPMENT USED	
	S-30
LEAK INFORMATION	
Leak Consultant:	JT
Leak Class:	III
Leak Rate (GPM):	0.50
Cover Type:	ASPHALT
Site Marked:	YES
Mins. Pinpointing:	10

Recommendation(s): REPAIR / REPLACE

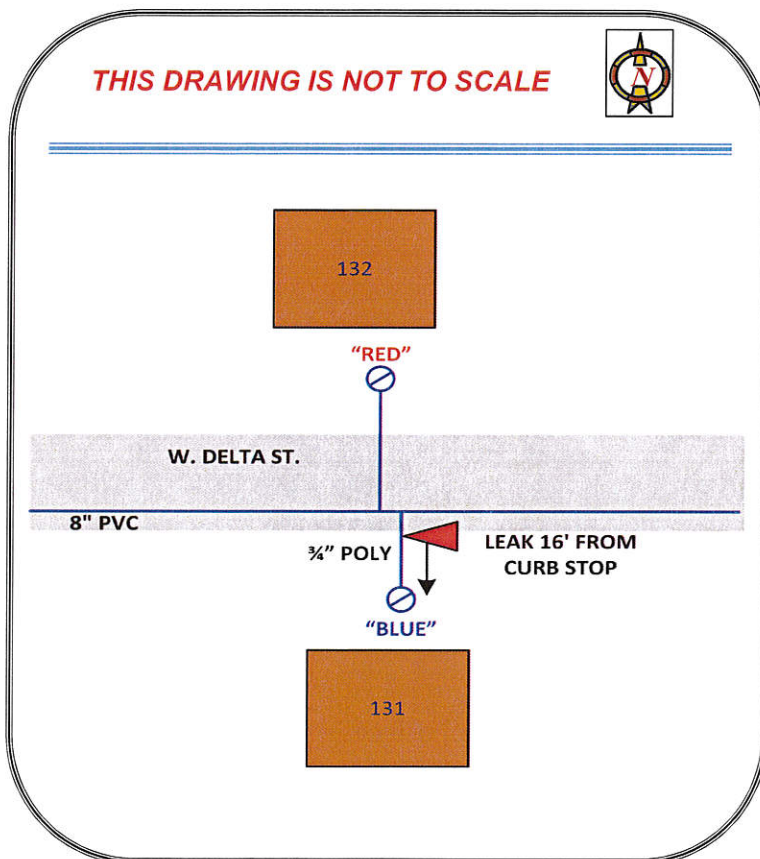
Leak #:	6
Date:	April 27, 2018
Map #:	
Coordinates	
45 52.4775N, 123 57.6261W

LEAK NOISE DETECTED AT CURB STOP WITH NO METER USAGE NOTED OR WATER ACCUMULATION PRESENT. FIRST SETUP WAS CONFIRMED WITH THE GROUND MICROPHONE AT 16' NORTH OF THE CURB STOP. THE SECOND SETUP WAS UNABLE TO VERIFY THE FIRST DUE TO A LOWER GRADE RESULT DUE FROM PIPE TYPE AND/OR SOUND MATCH.

Leak Consultant:	JT
Leak Class:	II
Leak Rate (GPM):	1.00
Cover Type:	ASPHALT
Site Marked:	YES
Mins. Pinpointing:	60

Recommendation(s): EXCAVATE & REPAIR

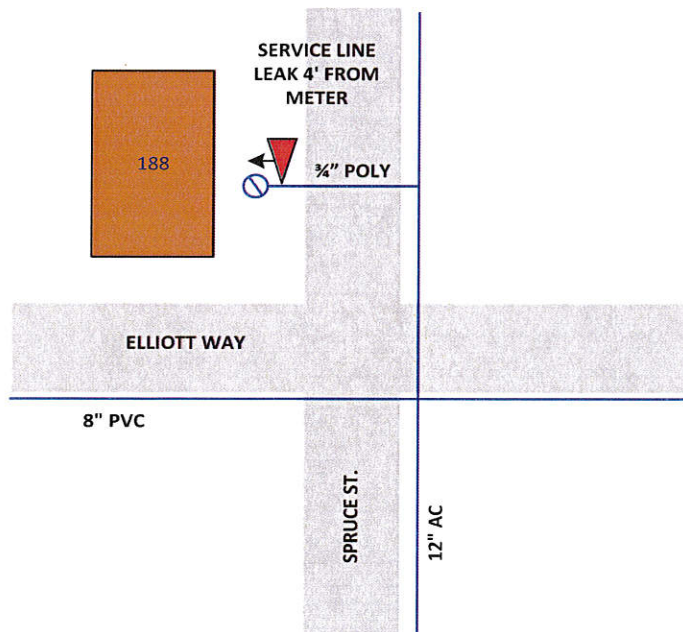
Leak #:	7
Date:	April 27, 2018
Map #:	
Coordinates

LEAK NOISE DETECTED AT CURB STOP WITH NO METER USAGE OR WATER ACCUMULATION PESENT. CORRELATION WAS INCONCLUSIVE, LIKELY DUE TO MAIN TYPE AND LENGTH. A PROBE ROD SURVEY WAS CONDUCTED WITH THE BEST LEAK NOISE BEING HEARD AT 4' TO THE EAST OF THE CURB STOP.

Leak Consultant:	JT
Leak Class:	III
Leak Rate (GPM):	1.00
Cover Type:	SOIL
Site Marked:	YES
Mins. Pinpointing:	50

Recommendation(s): EXCAVATE & REPAIR

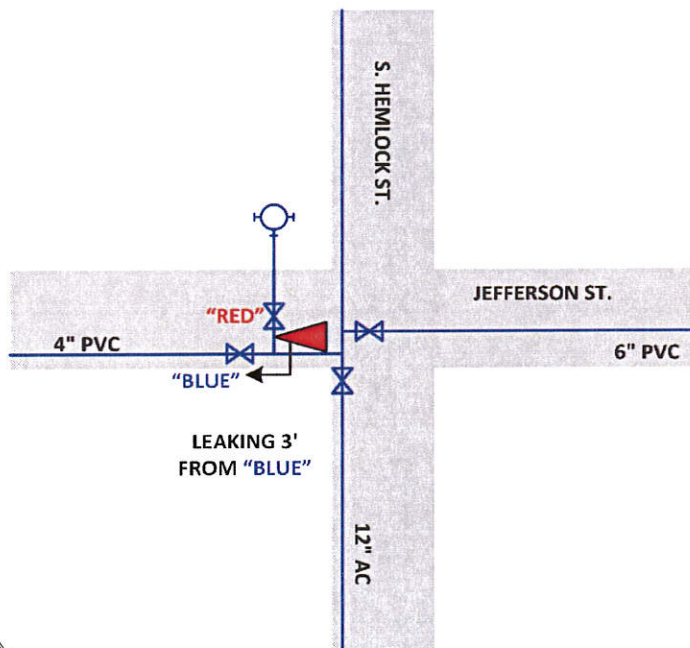
Leak #:	8
Date:	April 27, 2018
Map #:	
Lat:	
Long:

LEAK NOISE DETECTED ACROSS ALL VALVES IN THE CLUSTER. MULTIPLE SETUPS WERE DONE TO VERIFY THE PINPOINT LOCATION. THE HYDRANT VALVE WAS ISOLATED TO ELIMINATE FLOW, WITH NO CHANGE TO THE LEAK NOISE. ALL SETUPS INDICATE A LEAK ON THE SOUTH SIDE OF THE ISOLATION VALVE. THIS WAS CONFIRMED WITH THE GROUND MICROPHONE.

Leak Consultant:	JT
Leak Class:	II
Leak Rate (GPM):	5
Cover Type:	ASPHALT
Site Marked:	YES
Mins. Pinpointing:	45

Recommendation(s): EXCAVATE & REPAIR

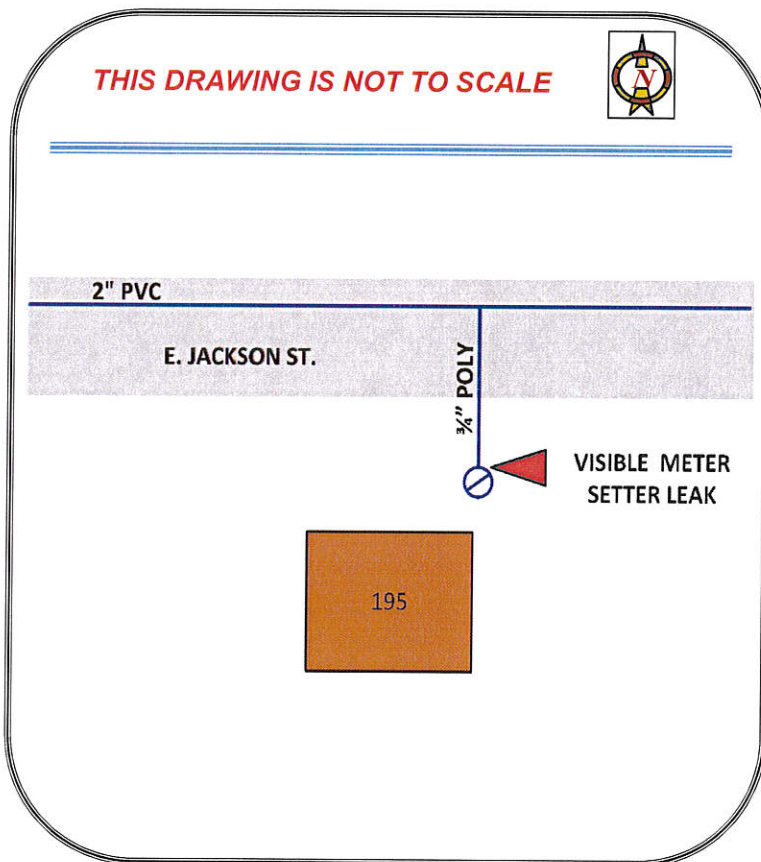
Leak #:	11
Date:	April 27, 2018
Map #:	
Coordinates

REMARKS
HIGH PITCH LEAK NOISE DETECTED AT THE CURBSTOP WITH WATER ACCUMULATION. VISIBLE LEAK FROM THE CURB STOP.

EQUIPMENT USED	
	S-30
LEAK INFORMATION	
Leak Consultant:	JT
Leak Class:	III
Leak Rate (GPM):	0.50
Cover Type:	METER BOX OR VAULT
Site Marked:	YES
Mins. Pinpointing:	25

Action(s) Taken: \_\_\_\_\_  
 Recommendation(s): REPAIR / REPLACE

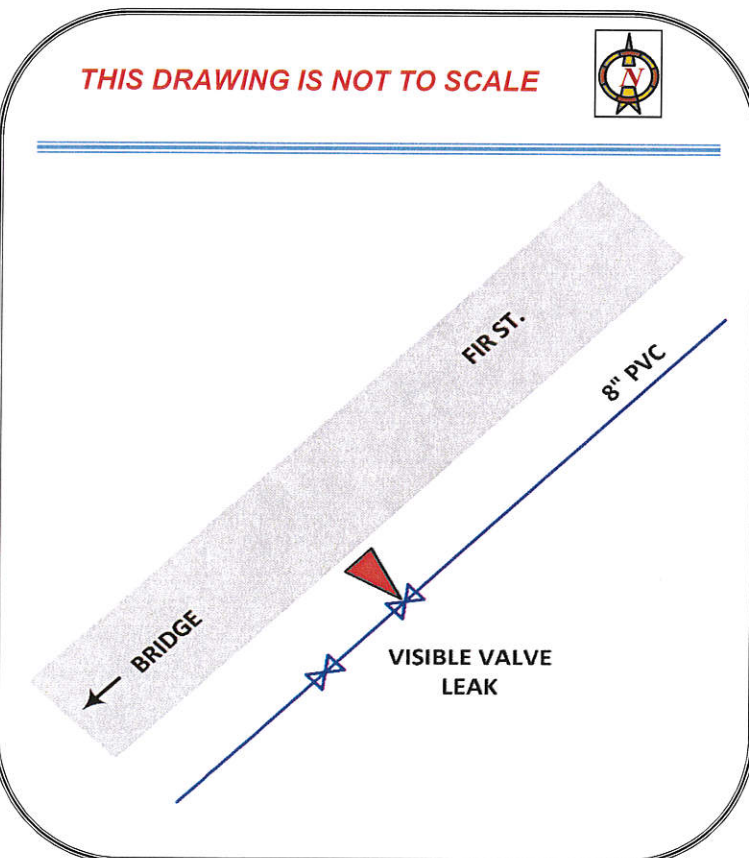
Leak #:	12
Date:	May 1, 2018
Map #:	
Coordinates

REMARKS
VISIBLE LEAK FROM VALVE STEM.

EQUIPMENT USED	
	S-30
LEAK INFORMATION	
Leak Consultant:	JT
Leak Class:	III
Leak Rate (GPM):	1.00
Cover Type:	SOIL
Site Marked:	YES
Mins. Pinpointing:	10

Action(s) Taken:	
Recommendation(s):	REPAIR / REPLACE

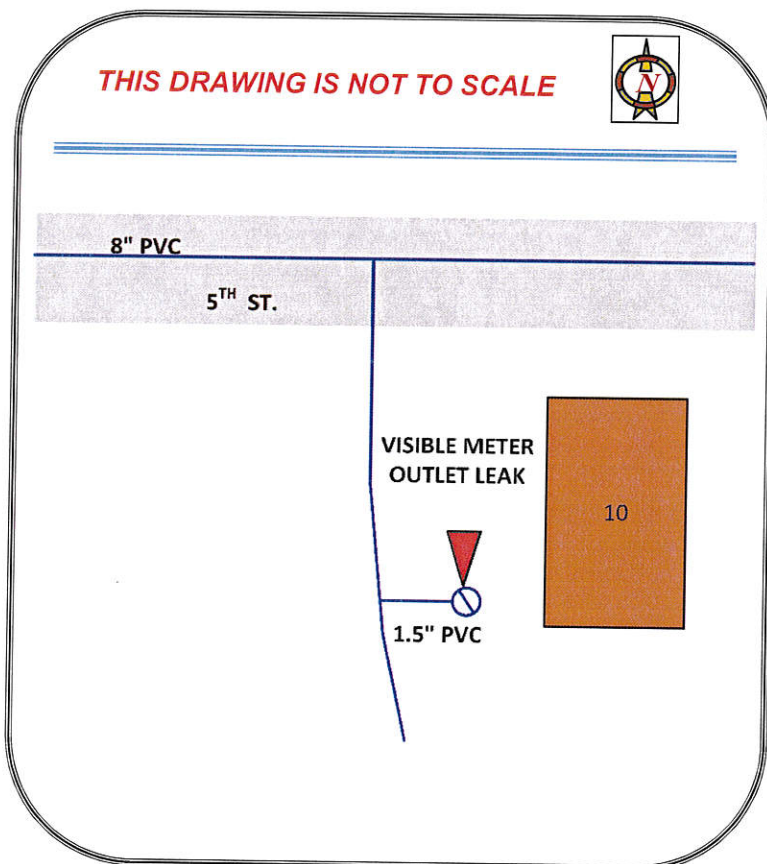
Leak #:	13
Date:	May 2, 2018
Map #:	
Coordinates

REMARKS
VISIBLE LEAK FROM THE METER OUTLET.

EQUIPMENT USED	
S-30	
LEAK INFORMATION	
Leak Consultant:	JT
Leak Class:	III
Leak Rate (GPM):	0.50
Cover Type:	SOIL
Site Marked:	YES
Mins. Pinpointing:	15

Action(s) Taken: Recommendation(s): REPAIR / REPLACE

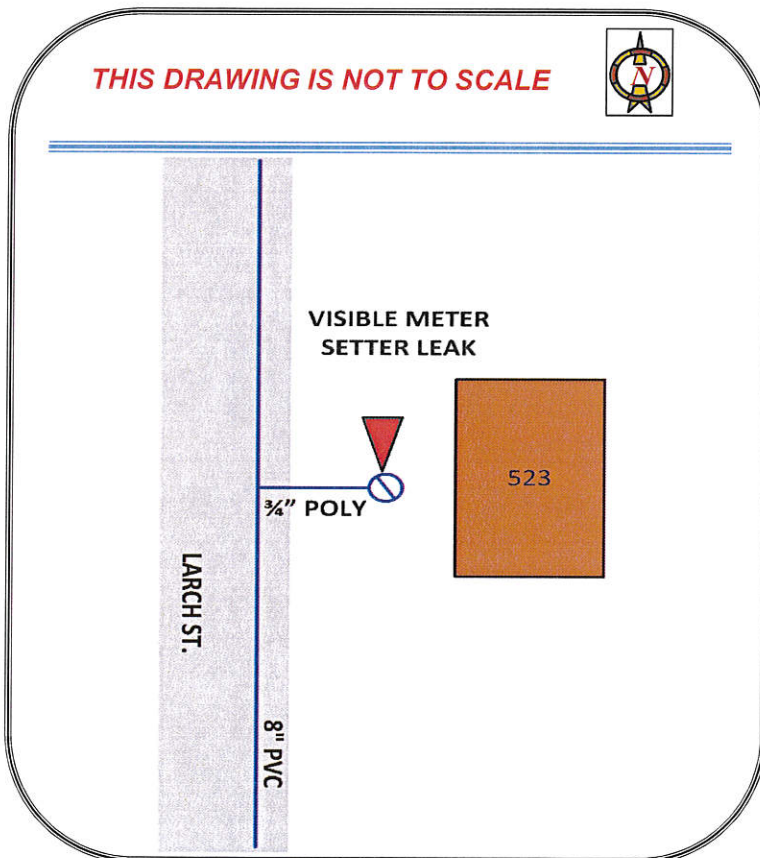
Leak #:	14
Date:	May 2, 2018
Map #:	
Coordinates

REMARKS
LEAK NOISE DETECTED AT THE CURB STOP. DUG OUT THE METER BOX TO REVEAL A VISIBLE LEAK FROM THE METER SETTER INLET.

EQUIPMENT USED	
	S-30
LEAK INFORMATION	
Leak Consultant:	JT
Leak Class:	III
Leak Rate (GPM):	0.25
Cover Type:	SOIL
Site Marked:	YES
Mins. Pinpointing:	30

Recommendation(s): REPAIR / REPLACE

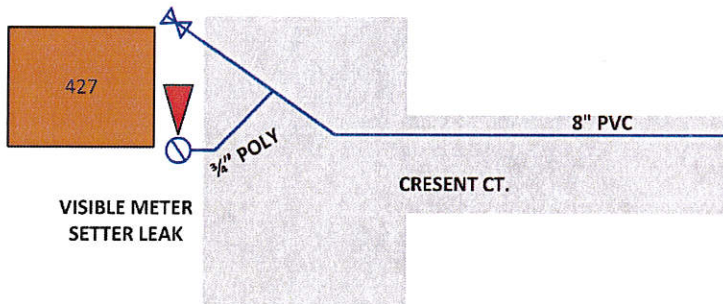
Leak #:	15
Date:	May 2, 2018
Map #:	
Coordinates

LEAK NOISE DETECTED AT THE CURB STOP, WITH WATER ACCULUTION IN THE METER BOX. PUMPED OUT BOX TO REVEAL A VISIBLE LEAK AT THE METER SETTER INLET.

Leak Consultant:	JT
Leak Class:	III
Leak Rate (GPM):	1.00
Cover Type:	SOIL
Site Marked:	YES
Mins. Pinpointing:	40

Recommendation(s): REPAIR / REPLACE

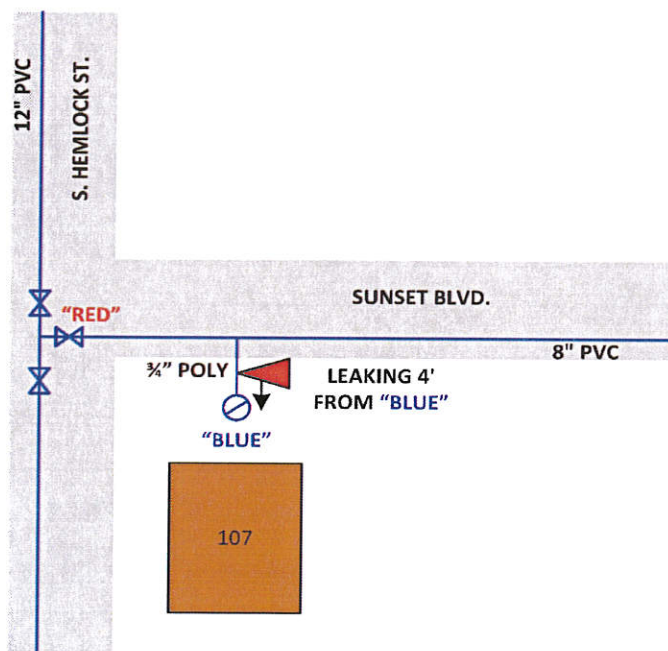
Leak #:	16
Date:	May 3, 2018
Map #:	
Coordinates

STRONG LOW PITCH LEAK NOISE DETECTED AT THE CURB STOP. ONLY SETUP YIELDED A LOW GRADE RESULT ON MULTIPLE NOISE FILTER SETTINGS. THE GROUND MICROPHONE CONFIRMED THE CORRELATION RESULTS AT 4' FROM THE CURB STOP.

Leak Consultant:	JT
Leak Class:	III
Leak Rate (GPM):	5.00
Cover Type:	CONCRETE
Site Marked:	YES
Mins. Pinpointing:	65

Recommendation(s): EXCAVATE & REPAIR

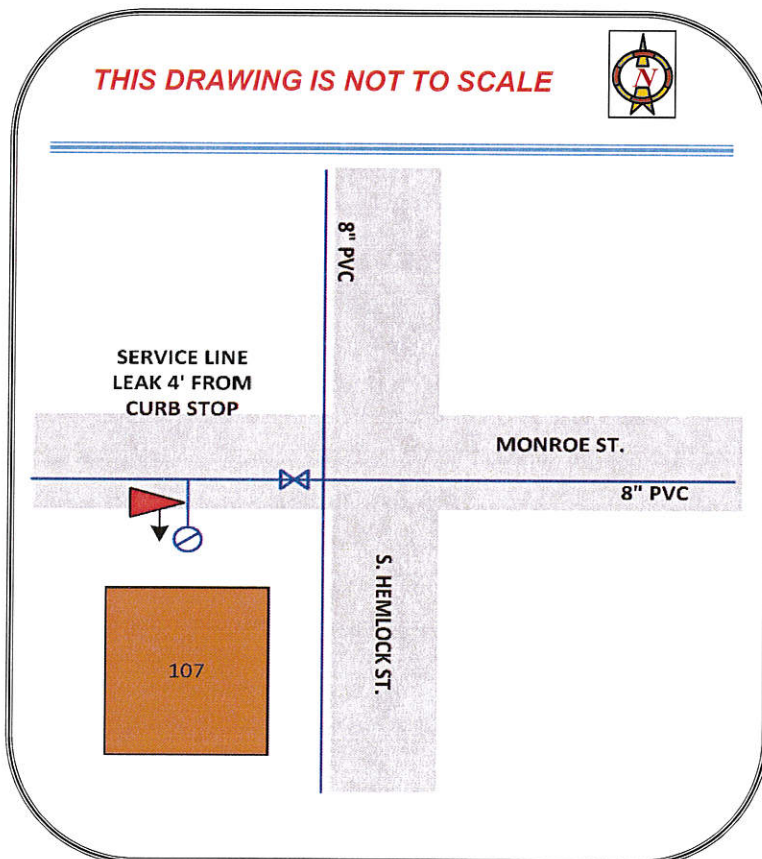
Leak #:	17
Date:	May 3, 2018
Map #:	
Coordinates

LIGHT LEAK NOISE DETECTED AT THE CURB STOP WITH NO WATER ACCUMULATION PRESENT. NO SETUPS WERE AVAILABLE DUE TO PIPE TYPE AND LACK OF CONTACT POINTS. A GROUND MICROPHONE SURVEY WAS CONDUCTED WITH A VERY STRONG LEAK NOISE DETECTED AT 4' FROM THE CURB STOP.

Leak Consultant:	JT
Leak Class:	III
Leak Rate (GPM):	1.00
Cover Type:	ASPHALT
Site Marked:	YES
Mins. Pinpointing:	40

Recommendation(s): EXCAVATE & REPAIR

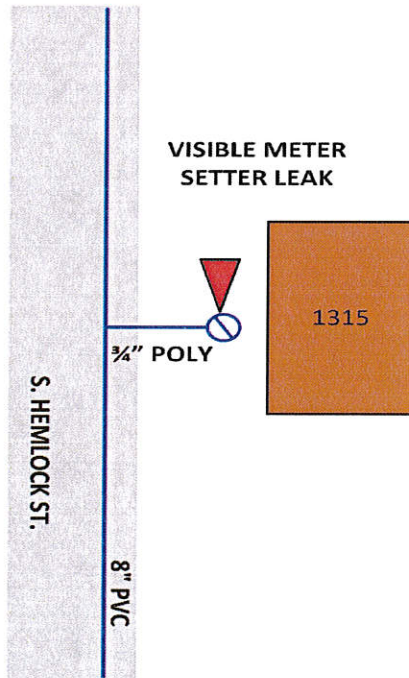
Leak #:	19
Date:	May 3, 2018
Map #:	
Coordinates

STRONG LEAK NOISE AT THE CURB STOP WITH WATER ACCUMULATION IN THE METER BOX. THIS IS A LOCKED OUT SERVICE WITH NO METER PRESENT. GROUND MICROPHONE SURVEY ALONG THE SERVICE LINE YIELDED NO DETECTABLE LEAK NOISES. THE METER BOX WAS PUMPED OUT AND WOULD REFILL AT A SIMILAR RATE. THE LEAK COMES FROM THE LOWER SETTER CONNECTION.

Leak Consultant:	JT
Leak Class:	III
Leak Rate (GPM):	1.00
Cover Type:	CONCRETE
Site Marked:	NO
Mins. Pinpointing:	50

Recommendation(s): EXCAVATE & REPAIR
