### Forest Lawn project arborist report

Location: corner of Hemlock St. and Forest Lawn Rd., Cannon Beach, OR  
Tax lot #: 51030DA04100  
Date: 12-28-2021

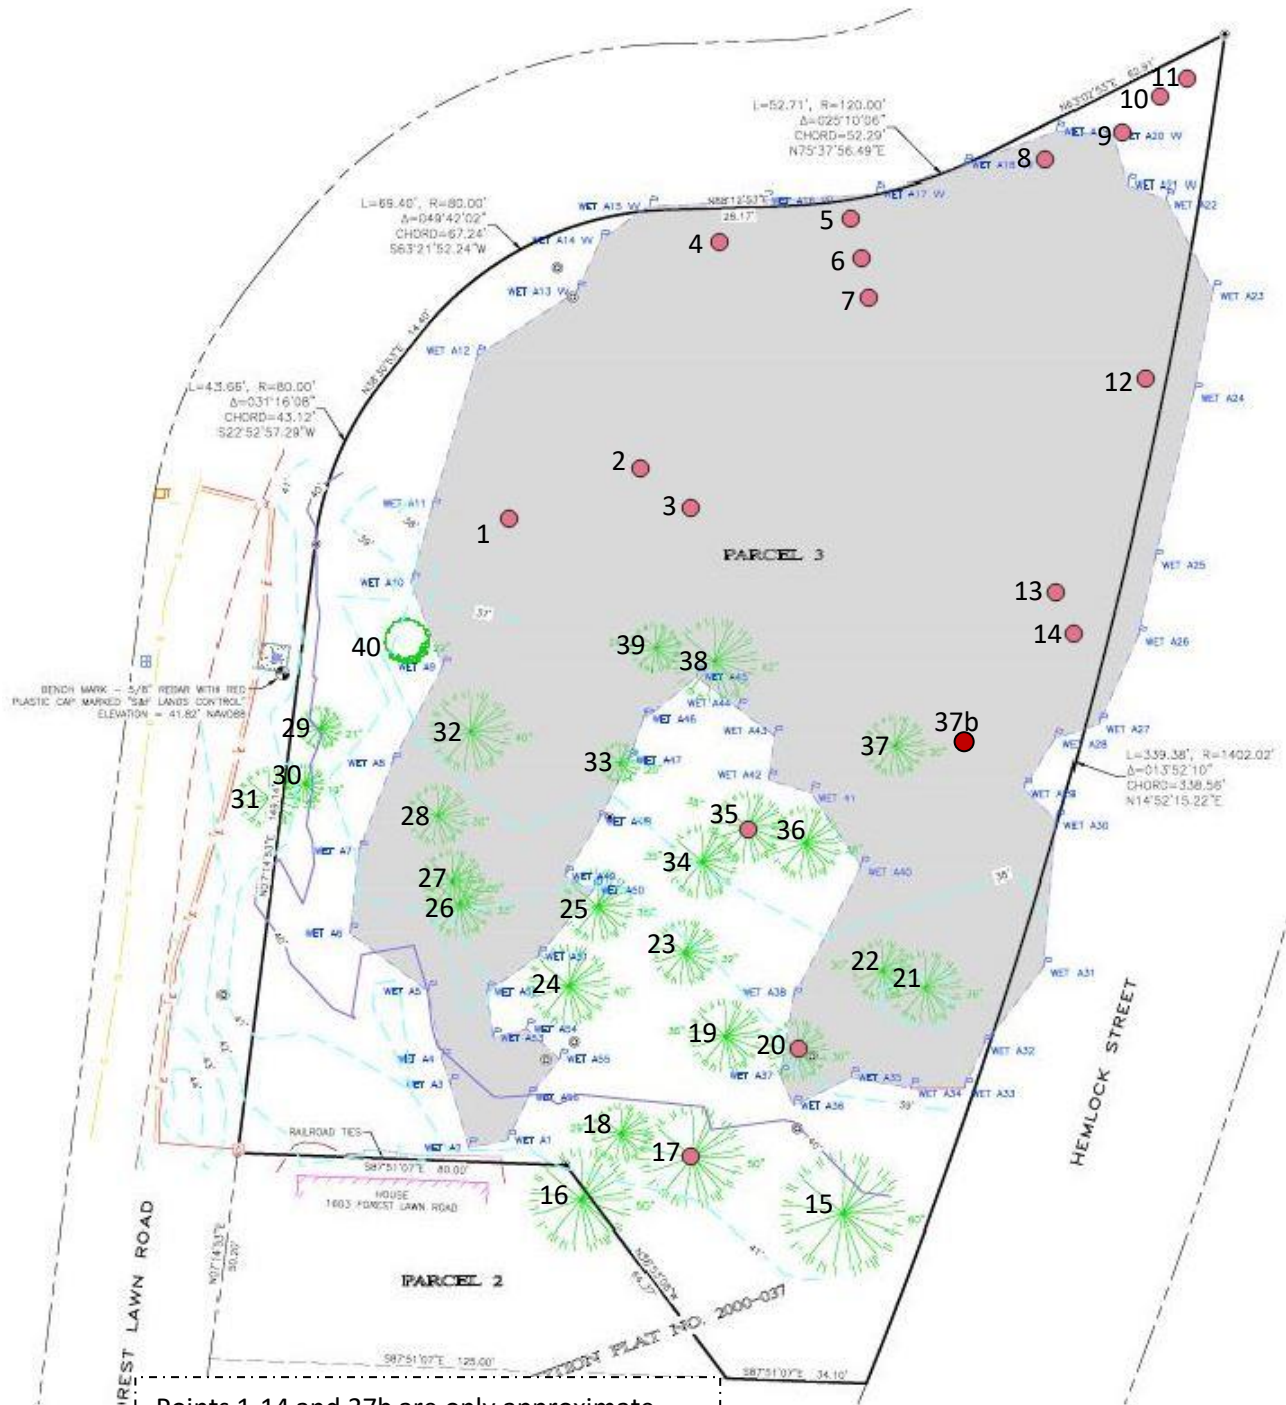
Map

Points 1-14 and 37b are only approximate locations
