Horning Geosciences

September 13, 2013

RE: Evaluation of Geologic Hazards for a 55-acre Site in Tolovana Park, east of Highway 101; Map 4 10 6B, northwest quadrant of Tax Lot 800.

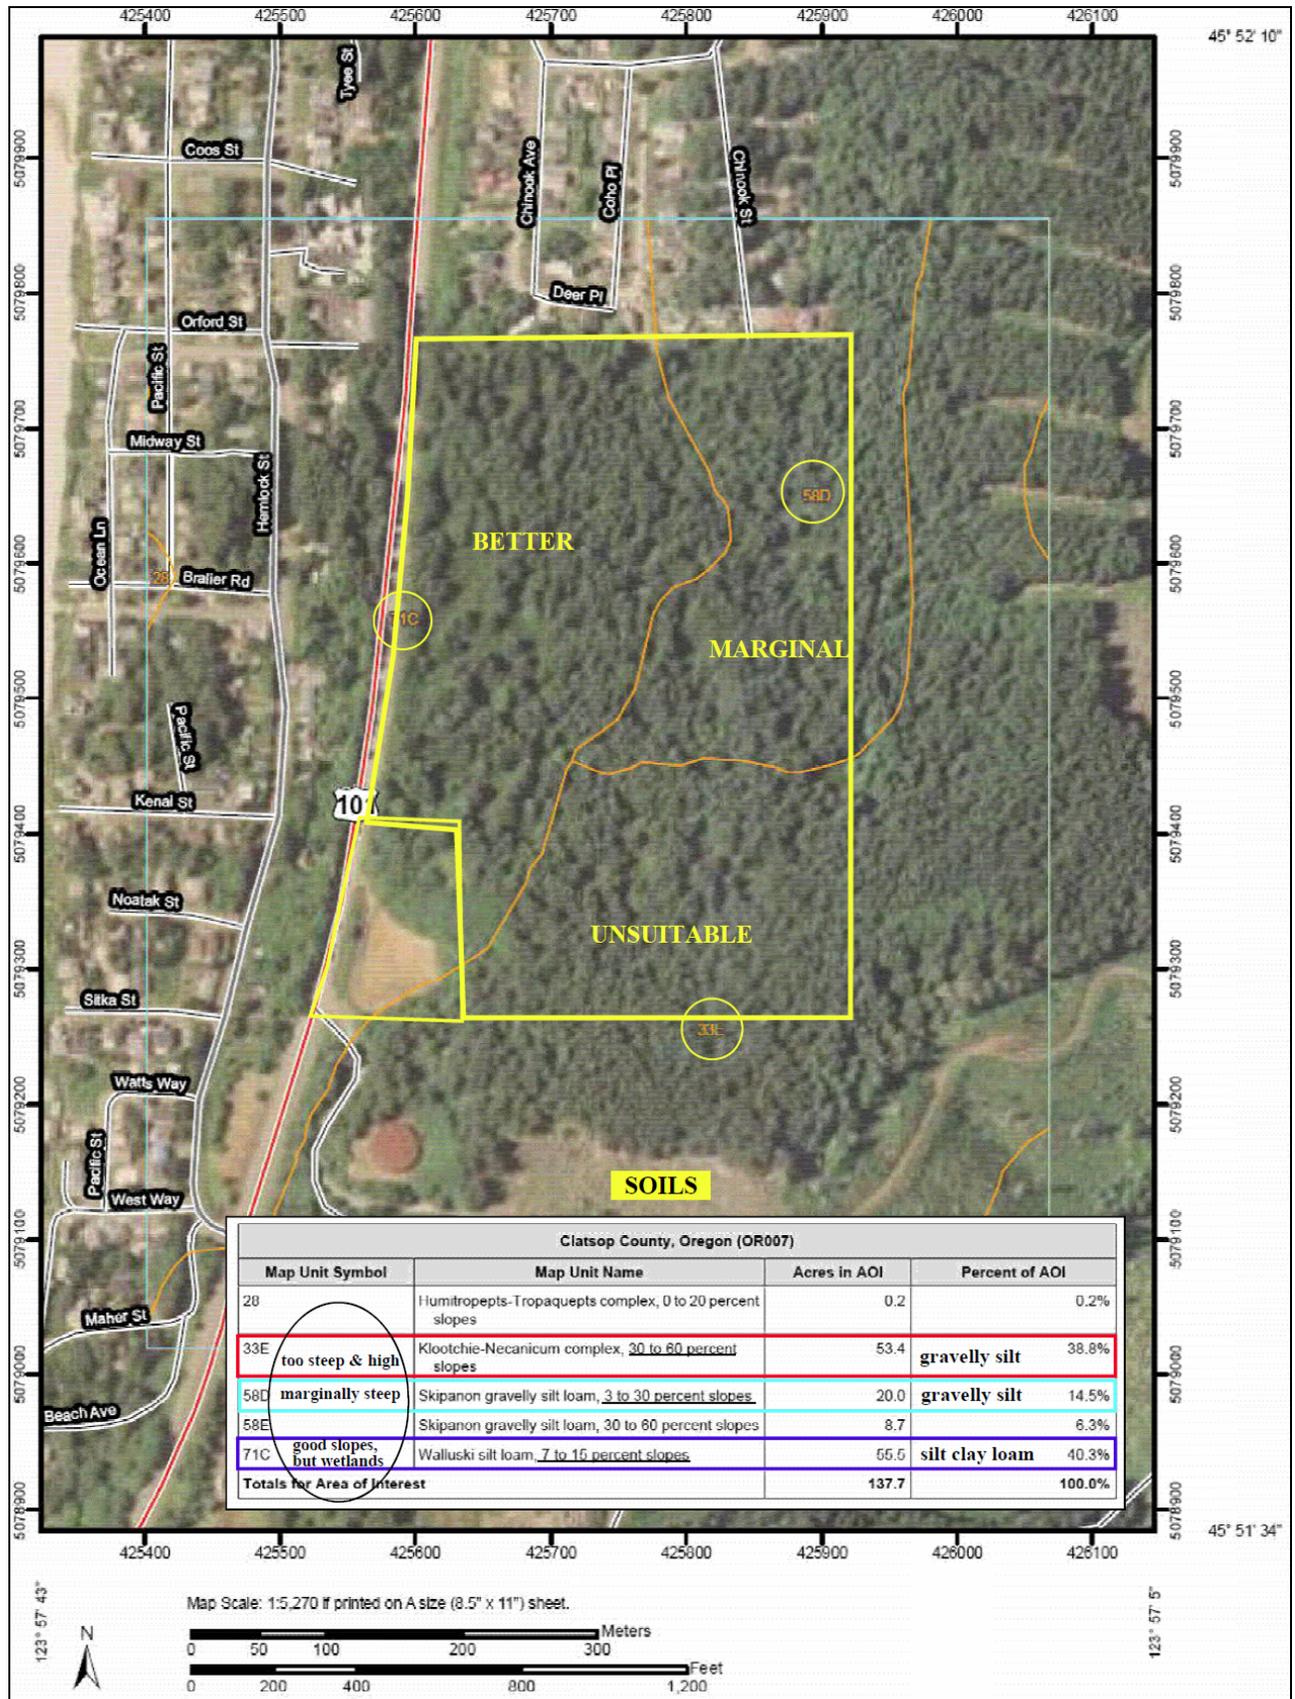
Figure 3: Soils map for the subject area with descriptions and relative ratings for geologic hazards, based on slope inclination. Terrace soils form gentle slopes, whereas bedrock soils form steeper slopes that may host landslides.

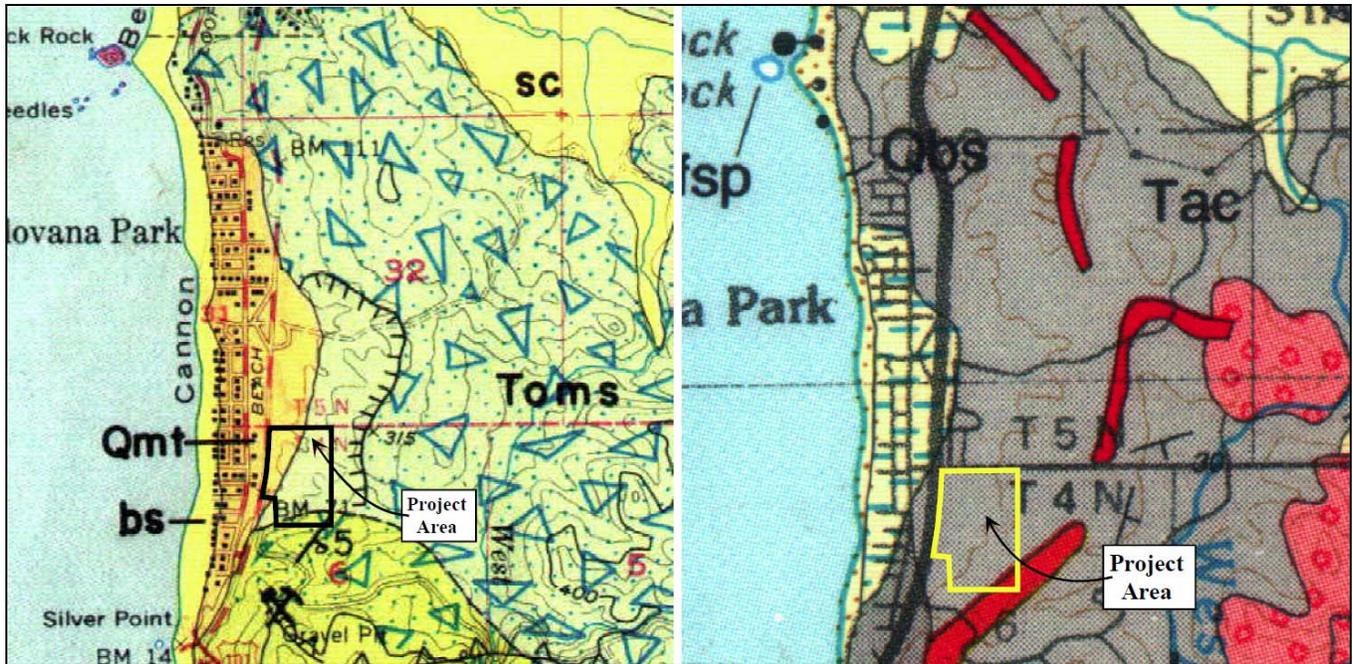
Figure 4: Geologic hazard and bedrock geology maps for the Tolovana Park vicinity; after Schlicker and others (1972) on right, and Niem and Niem (1985) on left. On right, the property lies partly on Pleistocene coastal terrace (Qmt) and partly on Oligocene to Miocene marine sedimentary rock (Toms), part of which forms a landslide on which the lot rests, as indicated by the barbed line. The landslide interpretation is not supported by LIDAR imagery. On right, the property is shown lying entirely on mudstone of the Cannon Beach member of the Miocene Astoria Formation (Tac), except for the extreme southeast corner of the lot, which is underlain by a dike of invasive Columbia River Basalt (red). The map errs by not showing marine terrace (dashed buff color) under the western part of the lot.

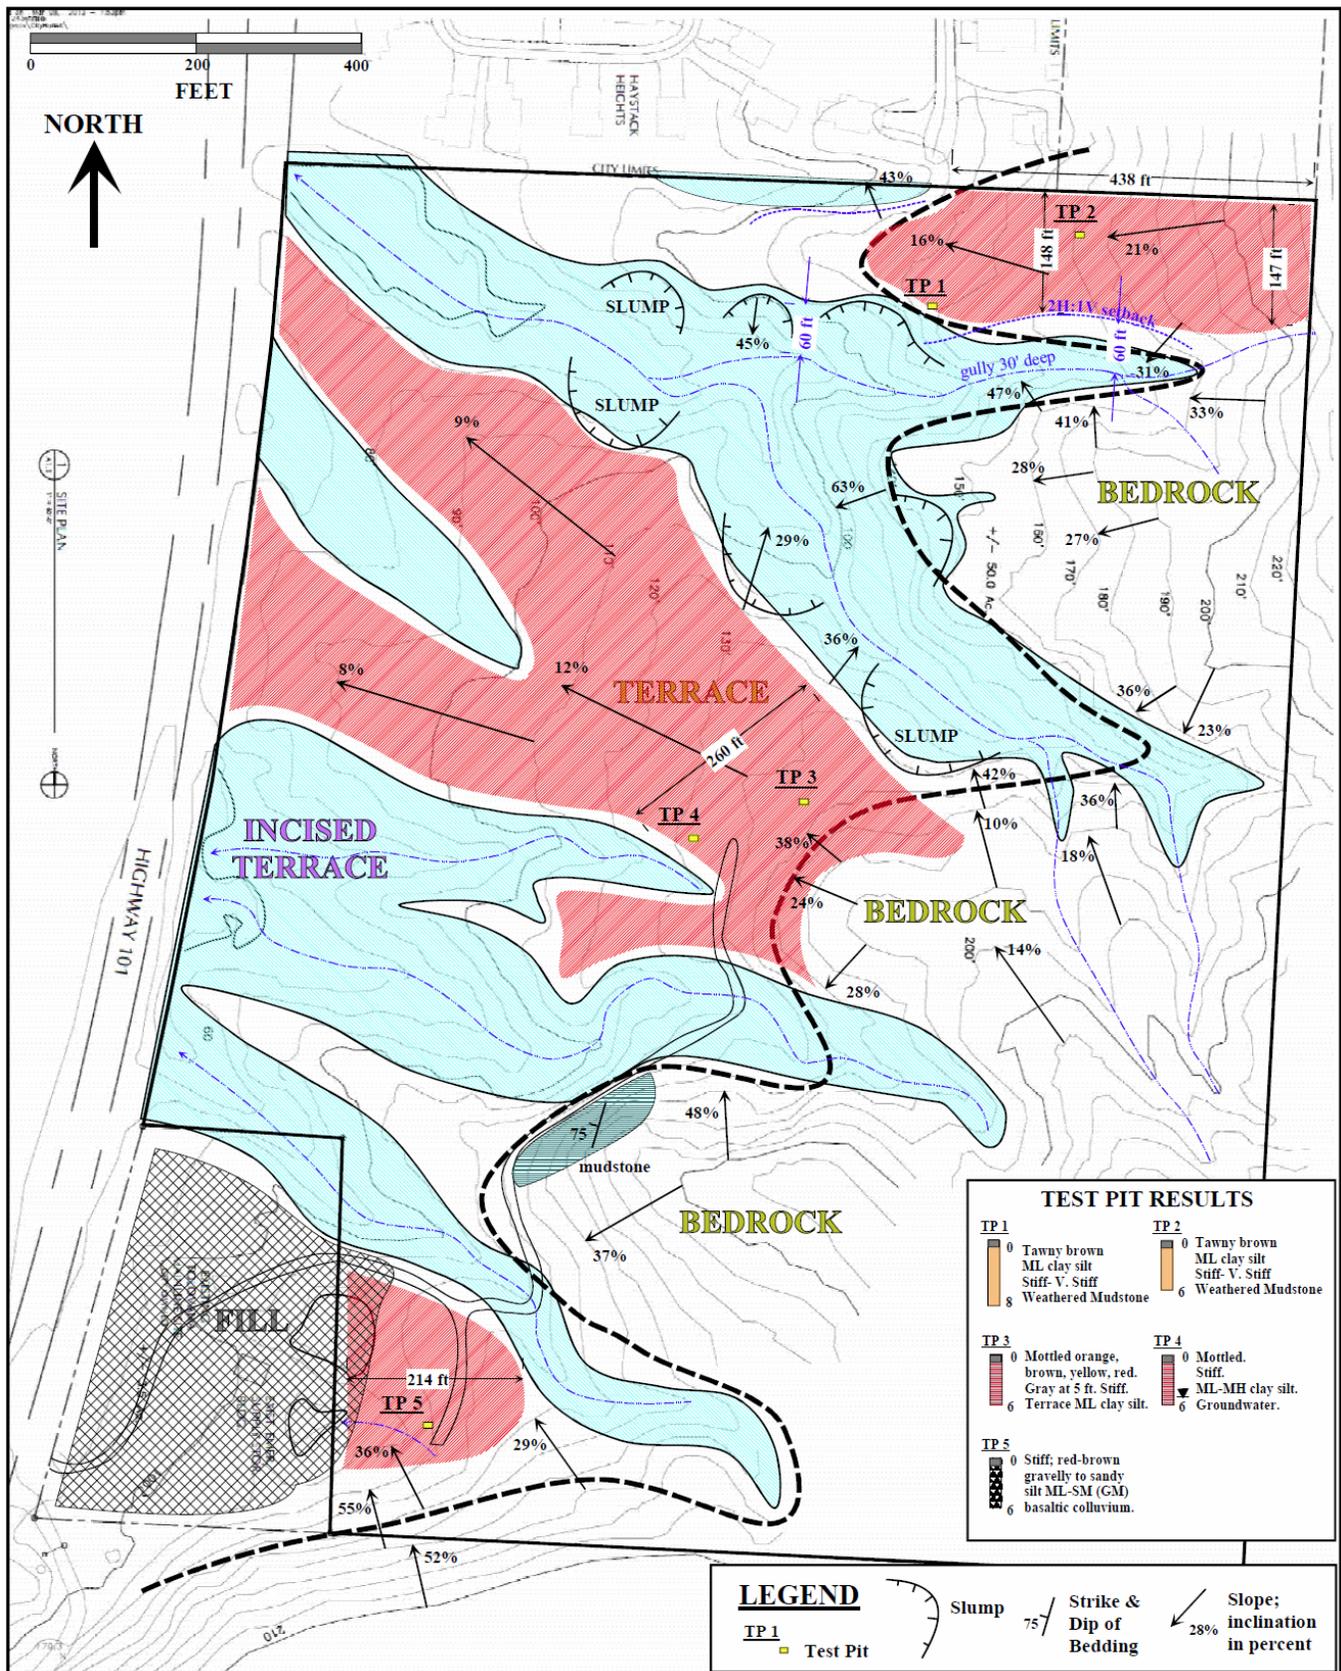
Land potentially available for construction at the North Site is about 150 ft wide north-south and about 440 ft long east-west. It slopes to the west at 16 to 21 percent. This is illustrated in Figure 5. The area is limited to the south by the proximity of a gully that is over 30 ft deep in places. Given that most of this gully has been incised into relatively weak bedrock mudstone, it would be appropriate to observe setbacks from the toe of the gully of at least 60 ft, based on a 2 Horizontal to 1 Vertical setback criterion that is commonly used for this type of material. A narrow septum extends farther to the west between the main gully and a smaller one to the north, but the septum is underlain by terrace sediment, which has slumped and produced a recessional escarpment that extends nearly 80 ft back from the gully bottom. Construction on the septum should be avoided. Soils consist of deeply weathered clay-silt with a Very Stiff Consistency that has a presumptive vertical bearing pressure of 1500 psf. The uniform texture of the soil suggests that it is composed of weathered mudstone. The soil is probably less than 12 ft deep. Seismic shaking amplification therefore will be limited. Shallow groundwater was not encountered.

Figure 5: Geologic map with test pit results for the 50-acre lot on which the school may be built. Areas of red hatching (North, Central, and South Sites) are generally suitable for construction, with respect to geologic hazards. Dimensions are provided for the sites. Blue hatched areas are incised gullies with saturated soils. More detailed maps for the three sites are provided in Figures 6, 7, and 8.

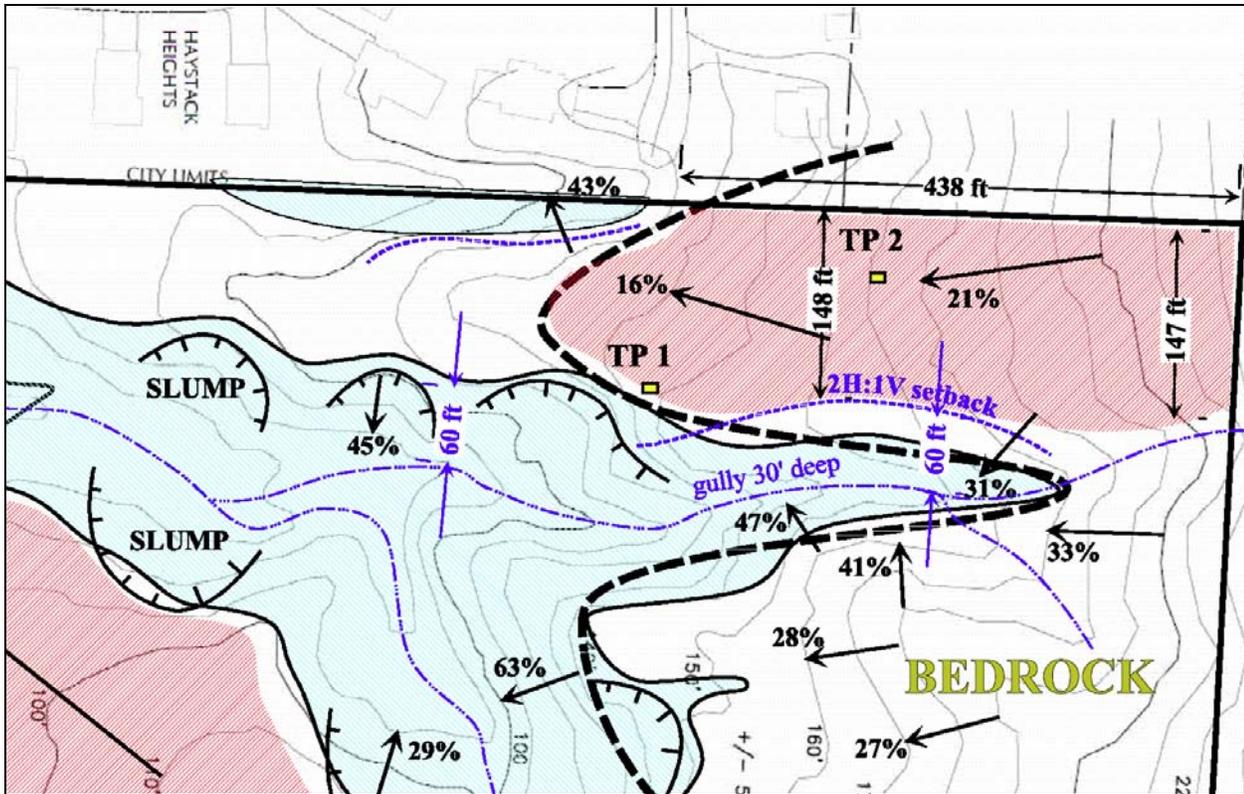
Figure 6: Geology of the North Site.

The North Site is constrained by its proximity to potentially unstable gully walls, but it does extend uphill from its access point at the southeast corner of the Haystack Heights neighborhood. Bedrock and thin soils will resist slope movements.

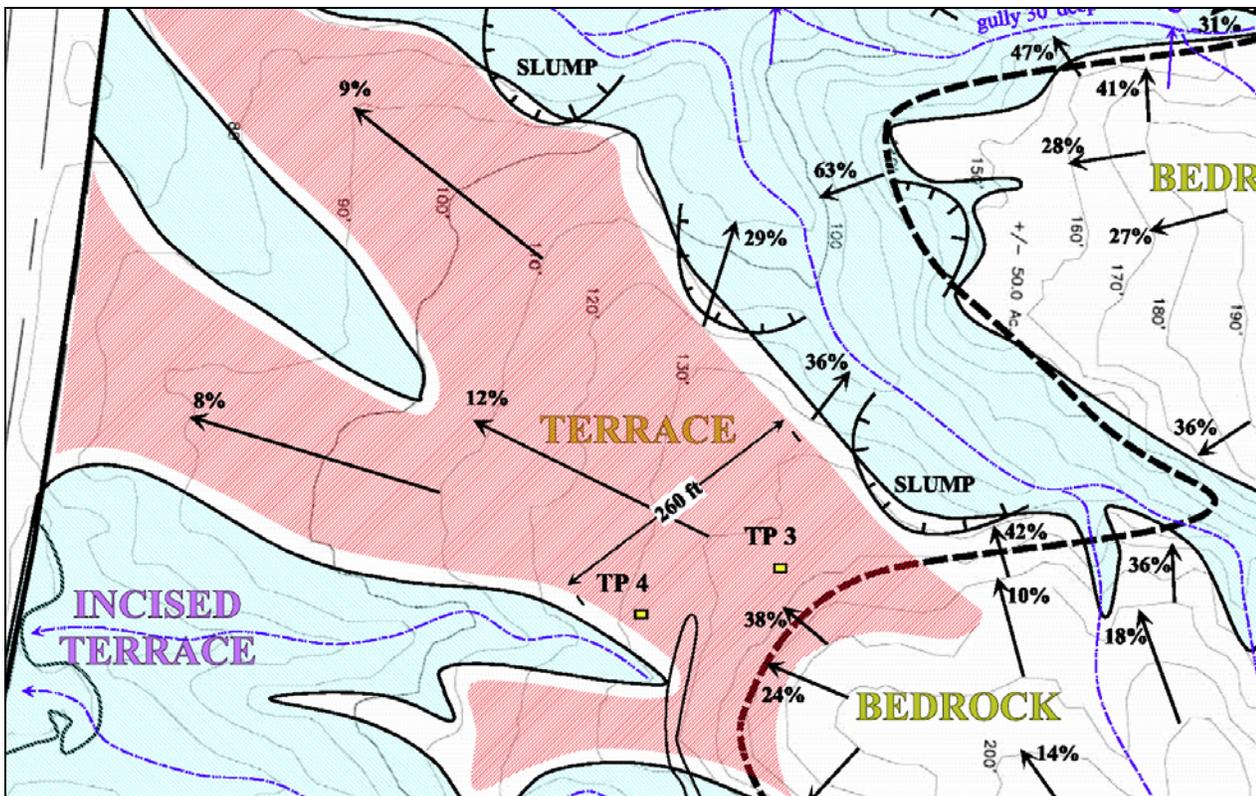
Figure 7: Geology of the Central Site.

Accessed by a single-lane logging road from the south, the Central Site has a minimum construction area of 260 ft by 400 ft, plus additional ground to the northwest and southeast. A narrow gully splits the northwest extension of the buildable area and could be filled in to provide added space. It slopes northwestward at 9 to 12 percent. Additional land lies higher on the hill to the southeast, where the ground is underlain by mudstone with slopes that range from 10 to 38 percent. Gullies have incised this eastern land and have made its development difficult due to potentially unstable slopes. Groundwater was encountered in one of the two test pits that were dug into the terrace sedi-

ments. The depth of the terrace sediment will be less near the bedrock contact, but will increase farther from it. Test pits exposed clay-rich sediments that may reduce the soil bearing capacity to 1000 psf. This can be mitigated with rock fill. The terrace sediments will tend to amplify seismic shaking, particularly if the depths of sediment approach 100 ft. During test pit excavation, ground waves could be felt by thumping of the machinery, indicating the generally weaker soil types. This will require added shear wall design to structures to mitigate lateral accelerations. Shallow groundwater encountered in test pits will require drainage controls. Foundations should be kept back at least 25 ft from the edges of the gullies to avoid future slumping. Access to the Central Site presumably will be by the route of the logging road presently on the property. It will be necessary to dig out the steeply dipping mudstone knob between the Central and Southern Sites in order to widen the access road and build it on firm ground, although this should not be difficult.

The Central Site provides the largest area for a school and playground, plus it has enough space to permit reasonable setbacks from slump-prone gully walls nearby. The soils of the Central Site are thicker and perhaps slightly weaker than the other two sites, but this can be mitigated by strengthening the shear walls and foundations to resist amplified seismic loads.

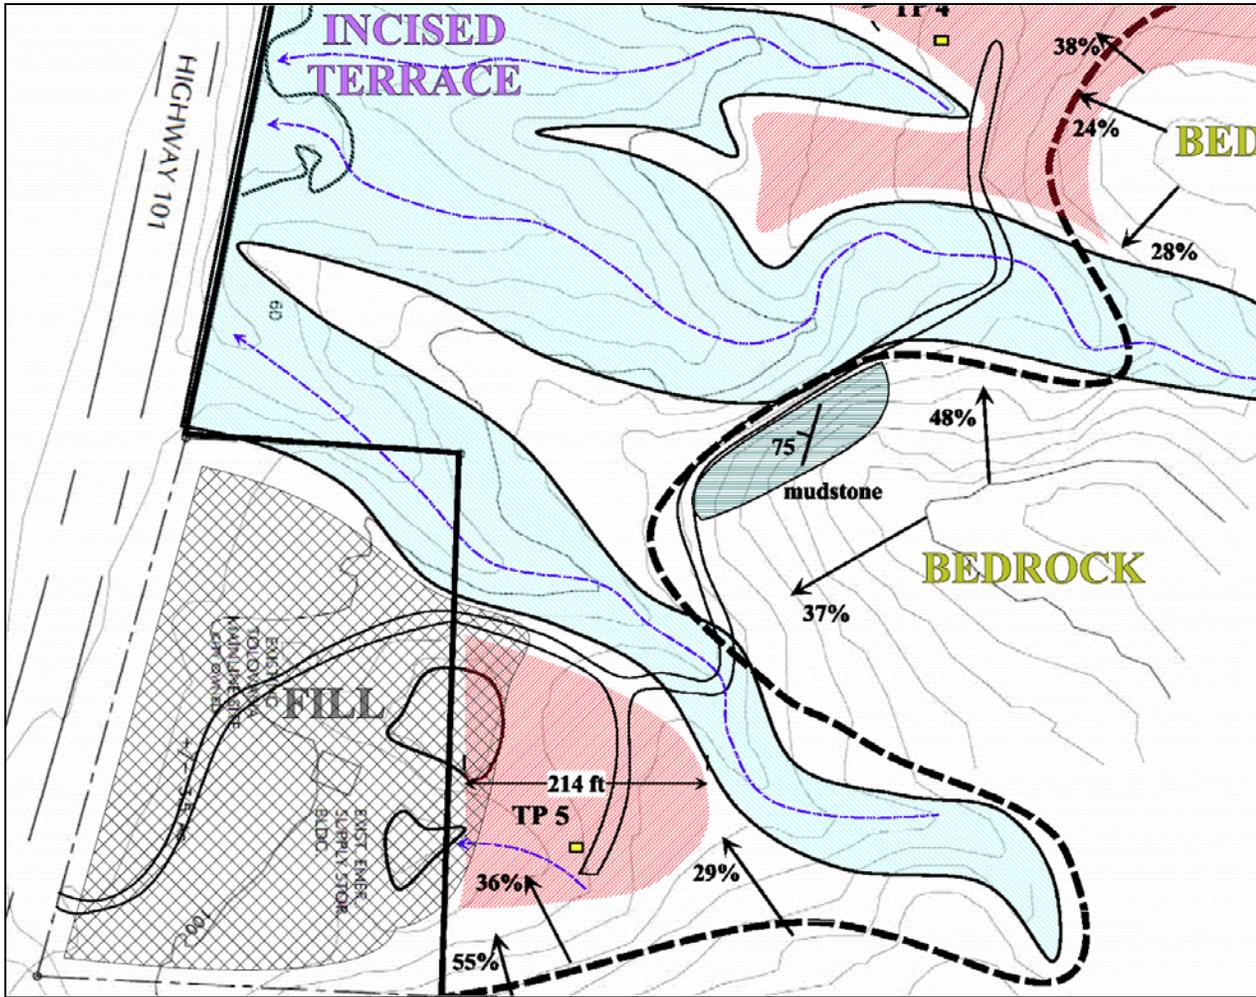
Figure 8: Geology of the South Site.

The South Site is located in a bowl-shaped amphitheater just east of the city storage building on the adjacent lot. The amphitheater aspect of the property is created in part by steep slopes to the south-southeast, where a dike of basalt forms a resistant steep ridge. Slopes in this area range up to 55 percent, an inclination steep enough to shed debris flows from intense soil saturation or seismic loading. An area of about 150 to 215 ft across could be filled in the lower part of the site to create a building pad, although may be likely that foundations may need to be stepped up the hill to offset the steep inclinations. There is some uncertainty as to how far away from the +50 percent slopes any structures should be placed. Test Pit 5 discovered soils that are rich in rock fragments, grits, and sand, apparently shed downslope by the nearby basaltic dike rock. The soils are clearly colluvial (landslide) in origin, but to what degree they formed by creeping soils or by debris flow cannot be determined. There is at least minor risk of debris flows from seismic shaking. When filling this site, it will be necessary to collect all ground water and pipe it away. The site can be filled properly with the appropriate structural aggregate.

The South Site is exposed to possible debris flows from 55 percent slopes to its south. This may be mitigated by siting the school as far north on the lot as possible and perhaps by constructing a barrier wall to resist future high-speed landslides.

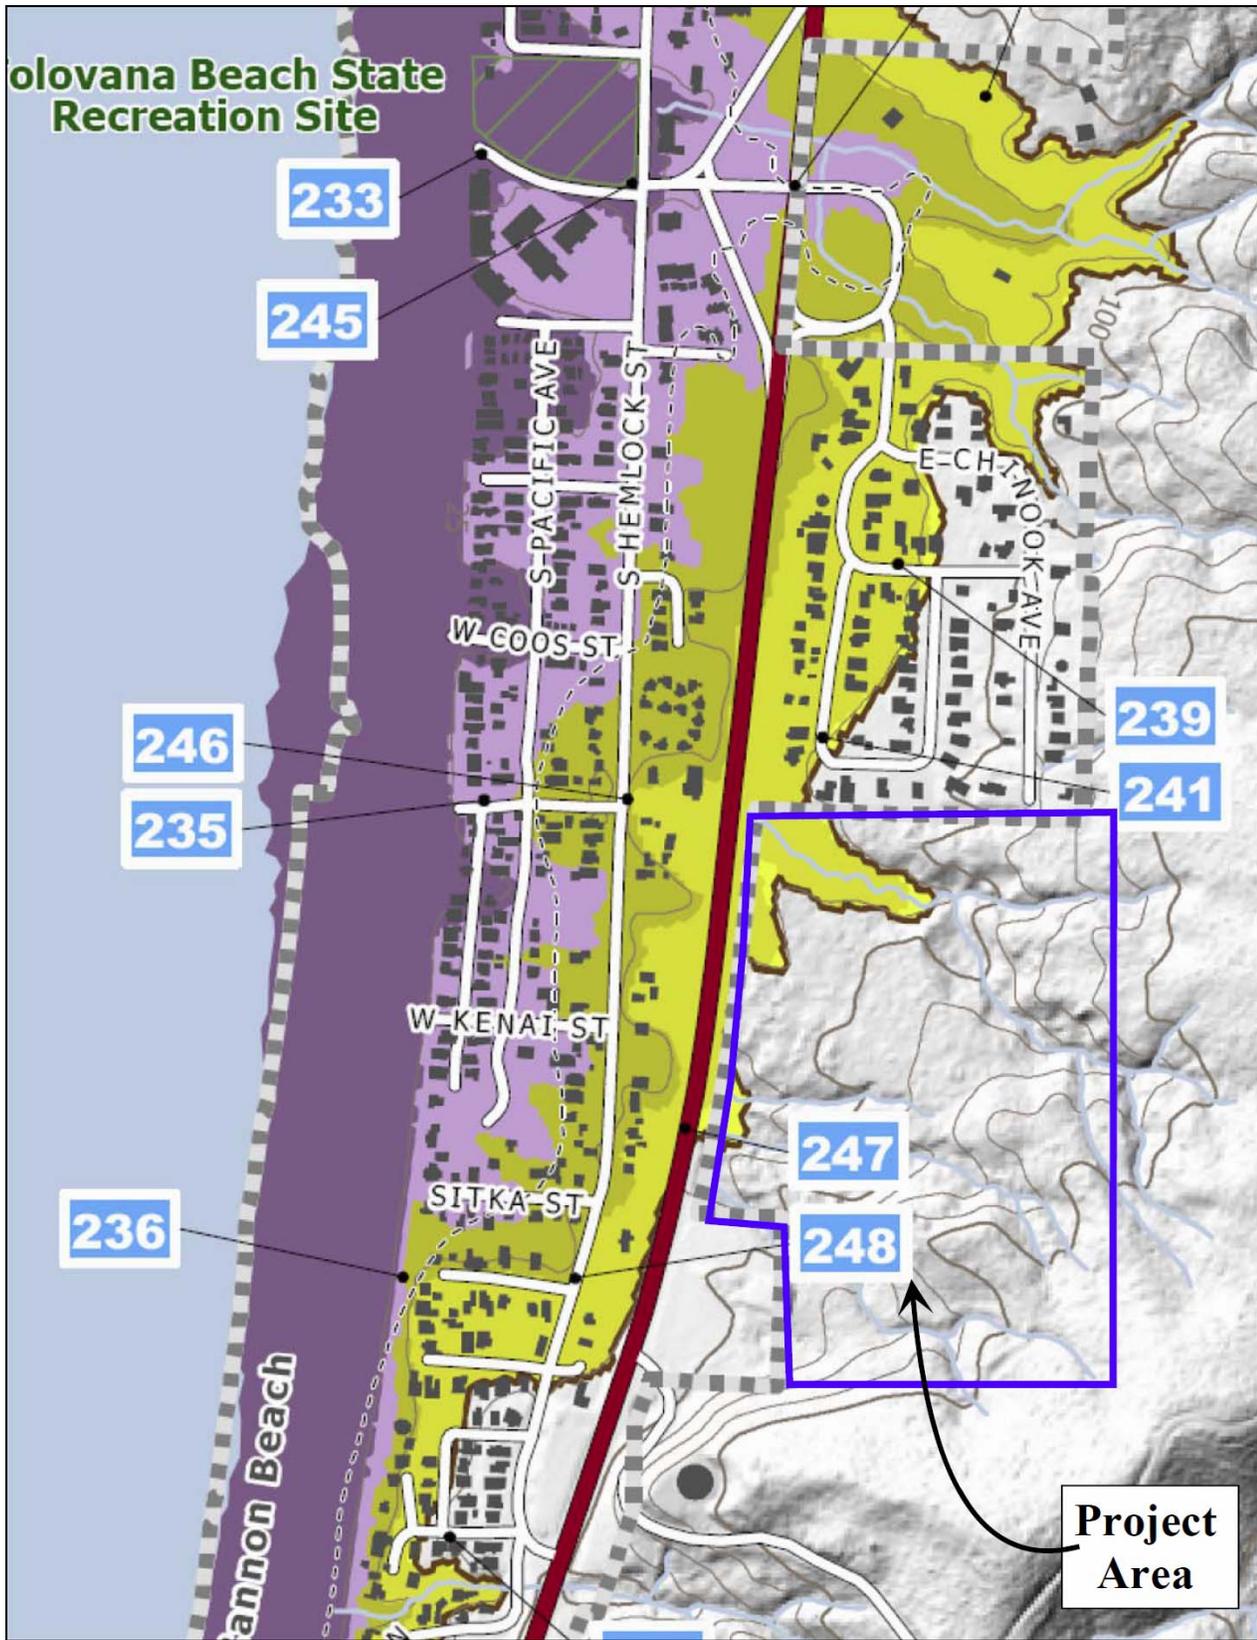
Figure 9: Tsunami run-up projections for Cascadia-sourced seismic sea waves. Minor flooding of the lower gullies may occur in the worst-case modeling scenario.
